NPG REPORT NO. 1158

Gunfire Tests of Vickers Incorporated
Cylindrical Accumulators for
Aircraft Hydraulic Systems

Project No.: TED No. NPG AE6233.2
No. of Pages: 9

Date: AUG 21 1953

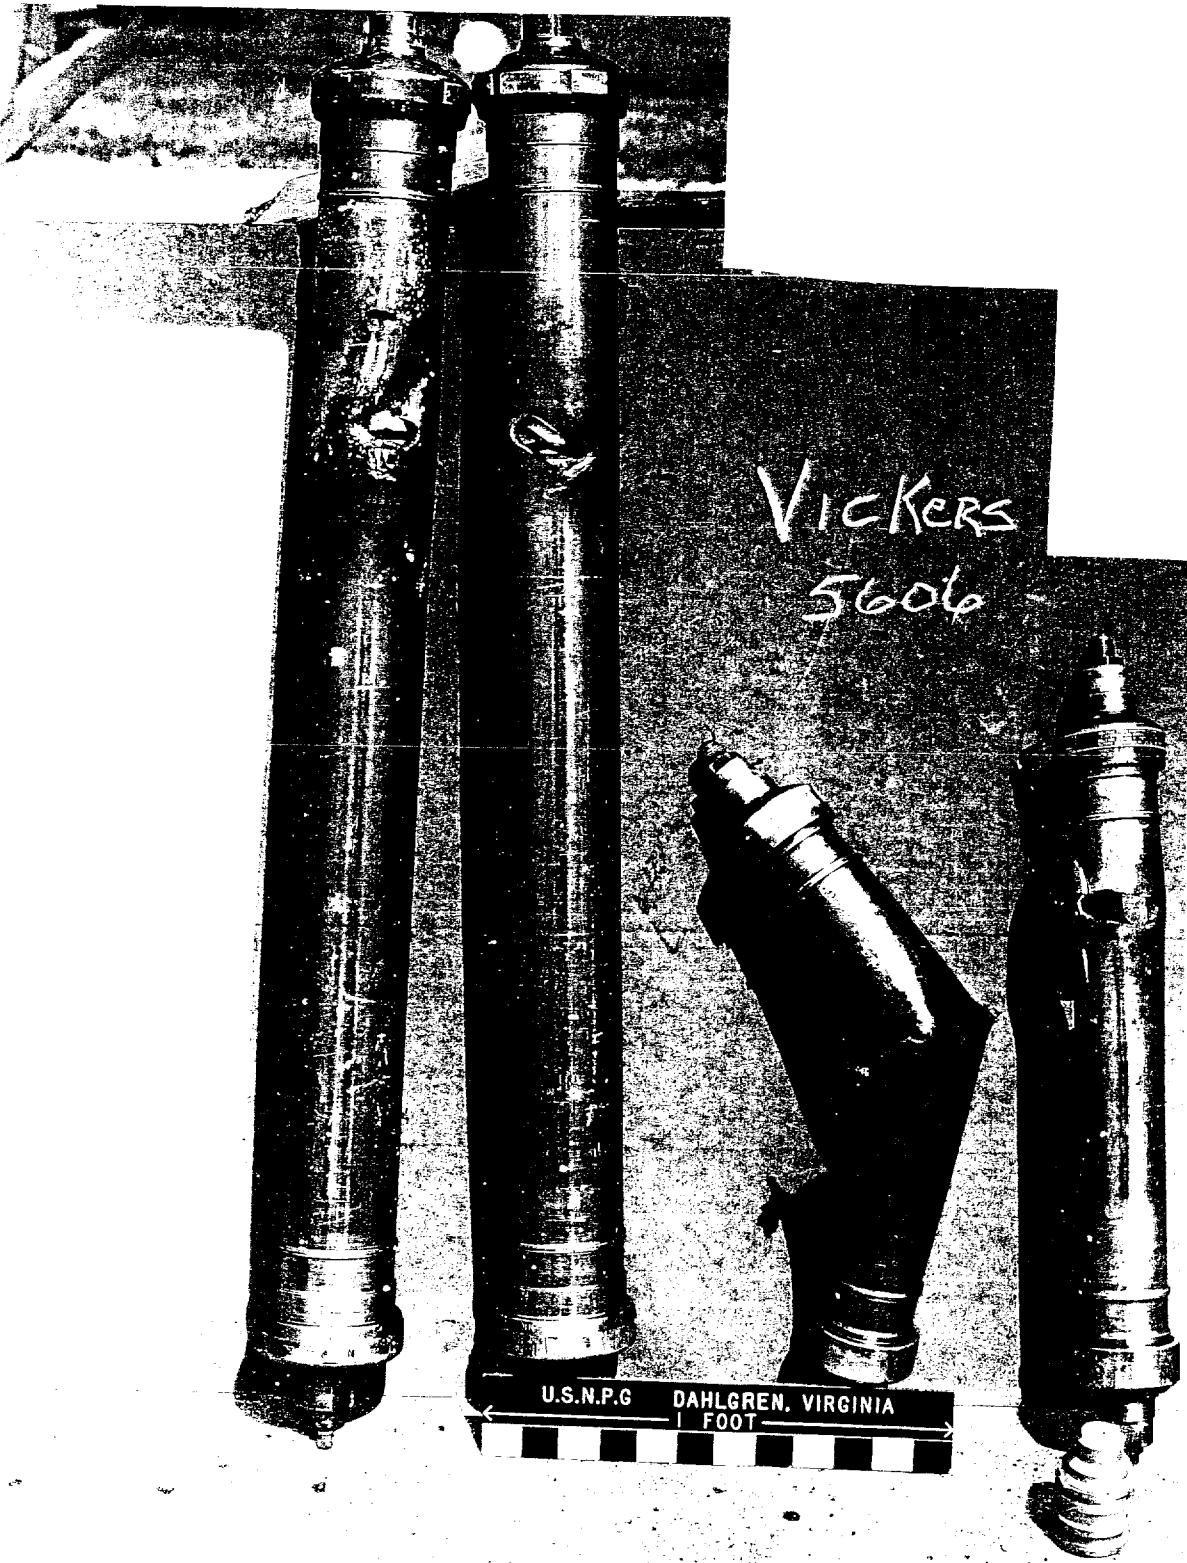
The first 50 cubic inch accumulator tested was Model AA24320 Serial L-1278. The following damage occurred as a result of the projectile impact and/or the force of the escaping fluid and air: the piston was ejected; the entrance hole inflicted by the projectile was 3/4-in. by 1-3/4-in.; and the cylinder wall through which the projectile made its exit split along its longitudinal axis five inches, flowering the wall.

The second 50 cubic inch accumulator tested was Model AA24320 Serial L-1280. The following damage occurred as a result of the projectile impact and/or the force of the escaping fluid and air: the piston was ejected; the entrance hole inflicted by the projectile was 3/4-in. by 1-1/4-in.; and the cylinder wall through which the projectile made its exit split along its longitudinal axis 13-1/4-in..

The two 200 cubic inch accumulators tested were Model No AA24350 Serial Nos. L-1277 and L-1279 respectively. The projectiles inflicted entrance holes of 3/4-in. by 2-in. and 1-1/8-in. by 1-3/8-in. in the two accumulators. The projectiles did not penetrate the opposite cylinder wall of the accumulators but there was a noticeable bulge in the wall of each. The piston of each accumulator was forced up to the entrance hole, where it jammed.

UNCLASSIFIED
Gunfire Test of Vickers Cylindrical Accumulators for Aircraft Hydraulic Systems.
View showing entrance wall of 50 and 200 cubic inch accumulators after being
attacked by .50 caliber incendiary projectiles. Accumulators were
not damaged.

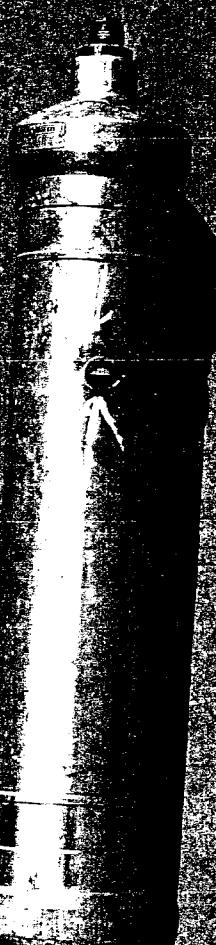
Figure 5

f. As an additional phase of the test, one 100 cubic inch accumulator was charged with air and non-inflammable Hydrolube hydraulic fluid H-2 and subjected to a non-tumbled .50 caliber incendiary projectile impact. This test was conducted to compare accumulators charged with Hydrolube with those charged with aircraft petroleum base hydraulic fluid, MIL-O-5606. The projectile inflicted an entrance hole of 5/8-in. by 3/4-in. and an exit hole 1-1/2-in. by 7/8-in. in the cylinder wall of the accumulator. A piece of the cylinder wall, 5/8-in. by 7/8-in., fragmented.

Gunfire Test of Vickers Accumulators for Aircraft Hydraulic Systems. View showing entrance wall of 100 cubic inch accumulator after being attacked by a .50 caliber machine gun projectile. Accumulator was charged with air and HydroTube hydraulic fluid.

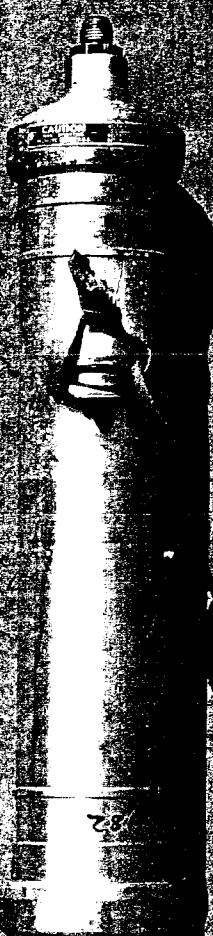
Gunfire Test of Vickers Accumulator for Aircraft Hydraulic Systems. View showing exit wall of 100 cubic inch accumulator after being attacked by a .50 caliber incendiary projectile. Accumulator was charged with air and Hydrolube hydraulic fluid. Figure 6.
